Hydroelectric generators: The forgotten mechanical component

R. Dreher, B. Sanosian, D. Erpenbeck and W. Akaishi, Stantec Power & Dams, USA

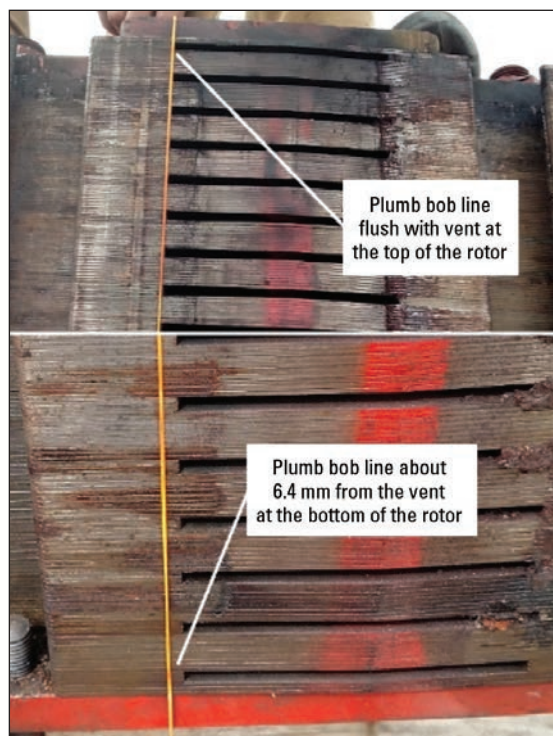
At a multi-unit refurbishment project, what started as finding crushed rim torque keys on one unit during the pre-project planning inspections led to determining that the original rotor rim design had insufficient original shrink and compression. All the rims were found to be 'skewed' to some extent where rim laminations had slipped relative to each other causing rim shape deformations from top to bottom while losing its shrink, which in turn had twisted and deformed the spider arms and imposed additional stress on the welding joints. The stresses and forces induced from this situation manifested themselves among different components. It was first seen as those crushed torque keys on one unit. During unstacking, another unit showed that the rim laminations themselves had twisted and buckled.

(b) Example of a skewed rotor rim.

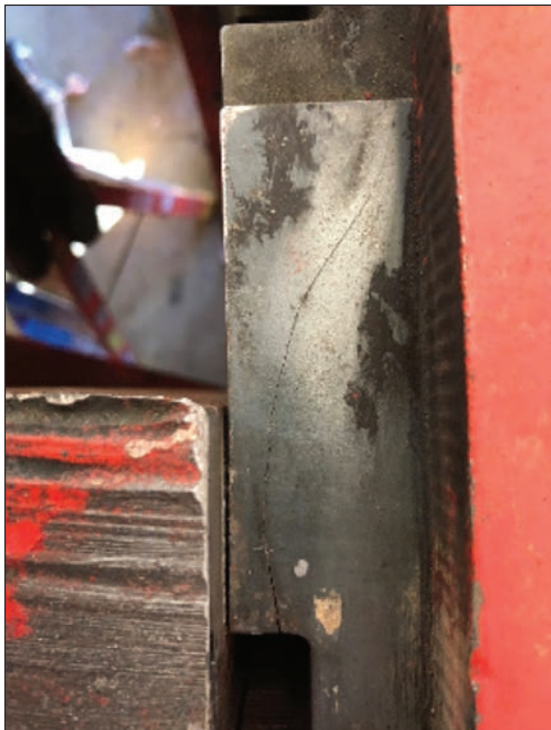
(c) Looking down on a cracked rotor rim lamination next to the shrink key slot.

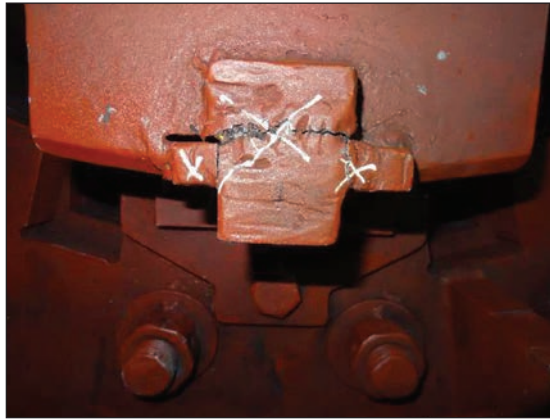
(f) Tangential crack on rotor radial key.
