Haldon Range Dam.

# Small dam, big task

Craig Scott from MWH gives an engineer's personal reflections on managing an emergency dam decommissioning

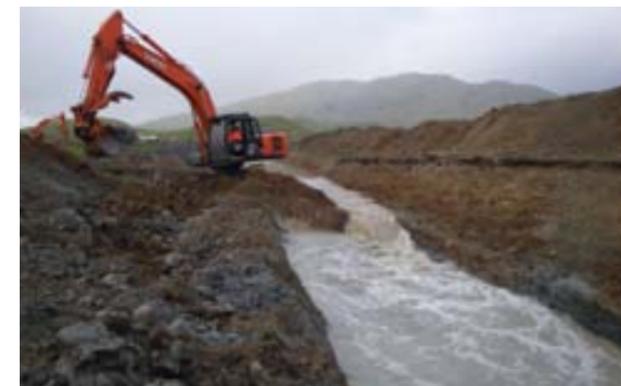
Excavation works in the spillway channel to lower the reservoir 1m. Excavating from the downstream spillway plunge pool back to the reservoir.

Contractors were on site two hours after my inspection and a series of four stages of excavation works were undertaken over the next seven days to lower the reservoir level 4m; a level I assessed as likely not to cause property damage in the event of a sudden release to the reservoir.

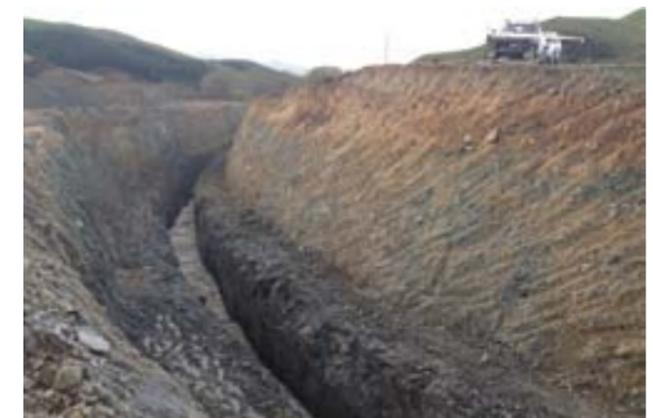
Excavation of the dam left abutment trench to lower the reservoir 4m. Discharge flow visible in the narrow cut at the base of the wide trench.

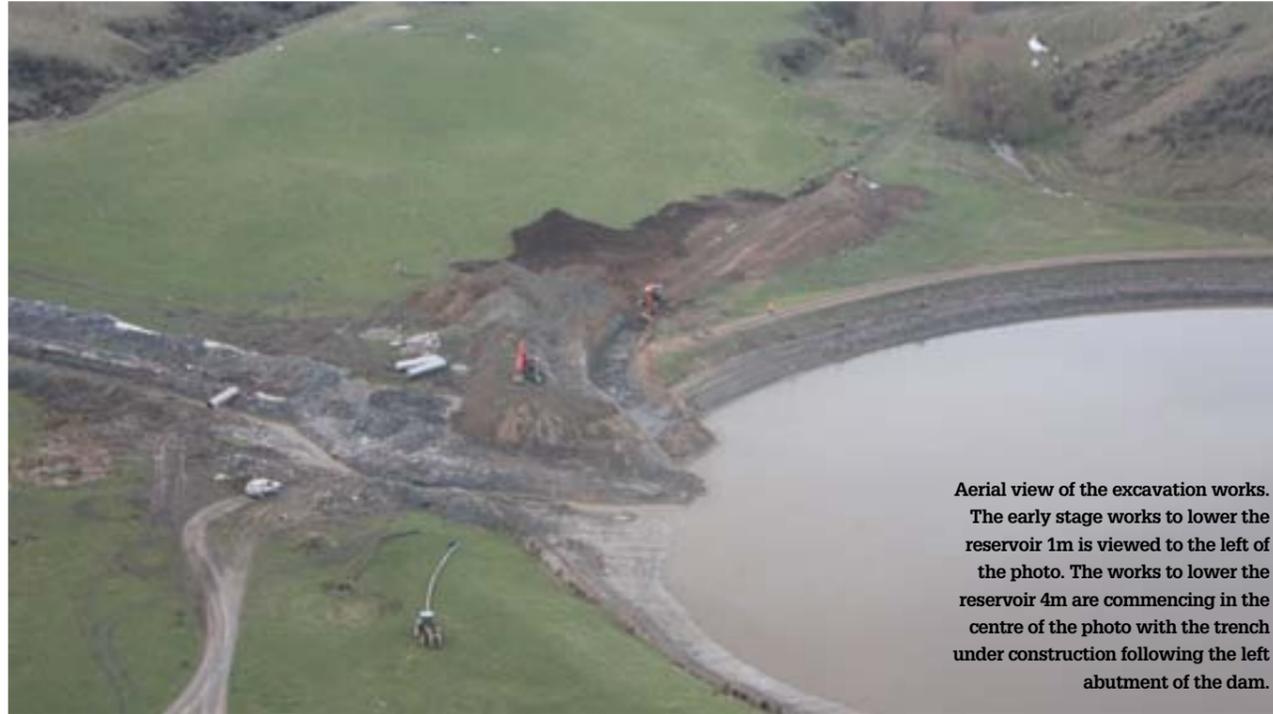
**Aerial view of the excavation works. The early stage works to lower the reservoir 1m is viewed to the left of the photo. The works to lower the reservoir 4m are commencing in the centre of the photo with the trench under construction following the left abutment of the dam.**

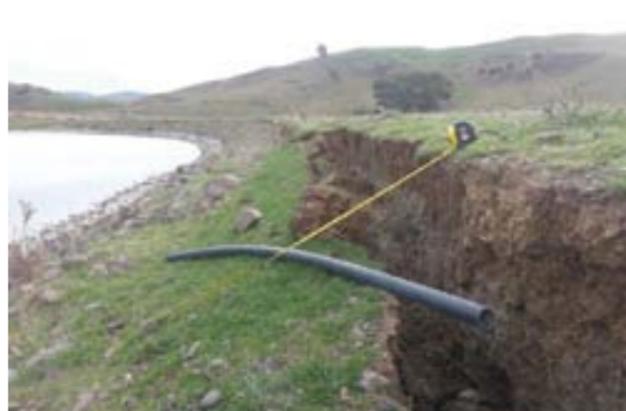
A month later, the Marlborough region and the dam was subject to a second series of earthquakes, this time much stronger with the epicentre very close to the dam location. Again I inspected the dam; noting significant crest cracking, right abutment separation, and complete slumping failure of the entire upstream face. In the region there was significant damage to regional infrastructure including homes, businesses and local infrastructure such as roads and bridges and services.

**Example dam upstream face slumping crack. This cracking extended the full length of the crest.**

The dam now is undergoing remedial works likely to include an upstream buttress, downstream buttress, filter/drainage improvements and alteration of spillway levels.

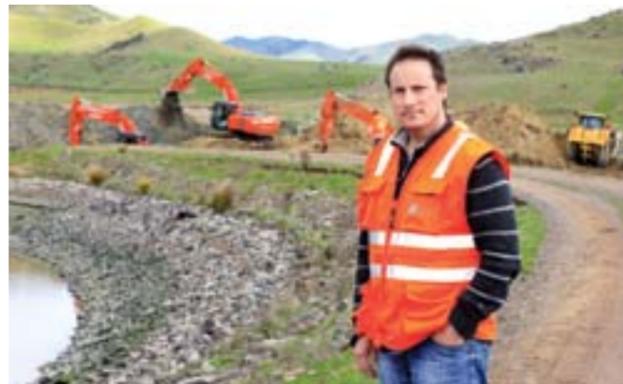
**Craig Scott gave his personal reflections on managing the dam emergency at Haldon range Dam. The photo shows equipment excavating the 4m lowering trench on the dam left abutment.**

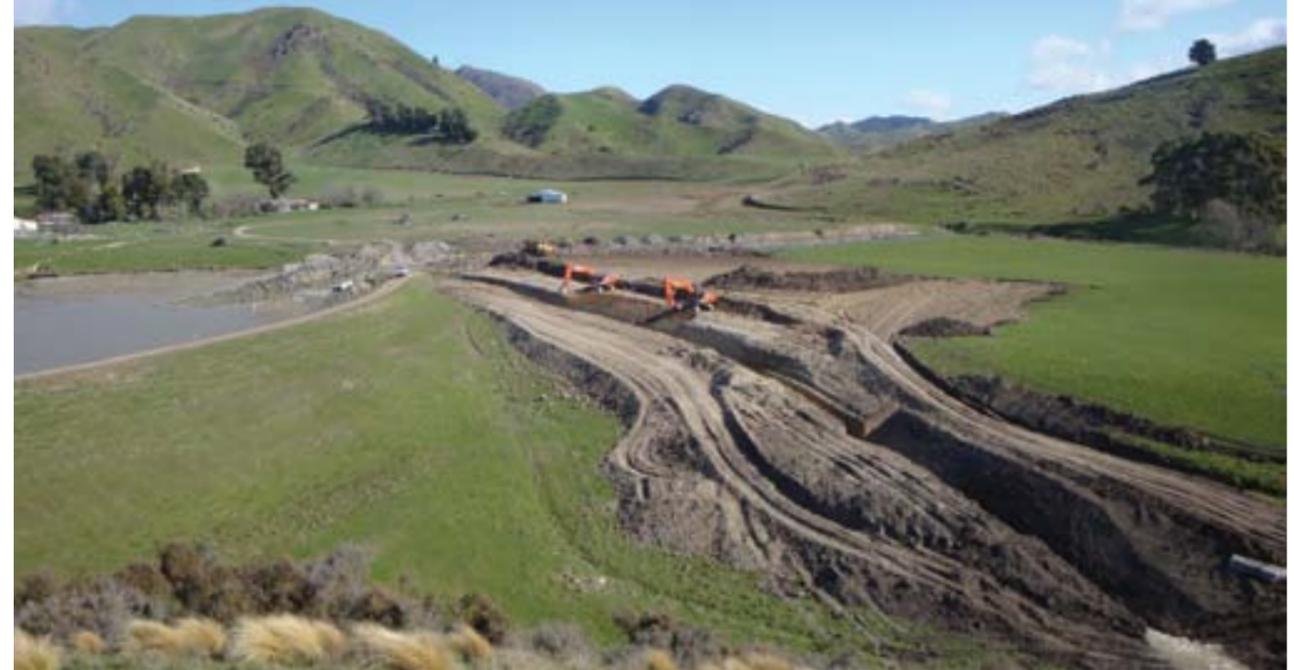
**Panorama view to the dam face with the extent of the excavation works to lower the reservoir 4m shown visible on the left abutment.**
