Data Management and Pipeline Integrity

Locating Pipe

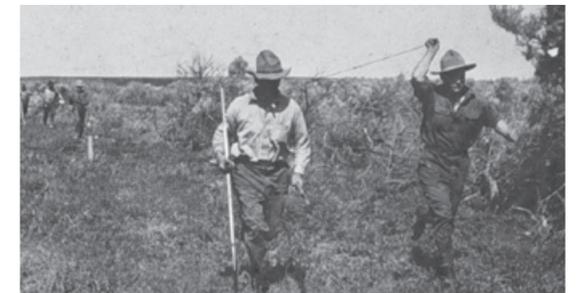
tape to physically 'chain' up to 2 miles along the pipeline right-of-way. Photo 1 predates modern pipelines but illustrates the technique:

↑ Photo 1: Historical Survey Tape Measurement
Credit: Hodgson^[1]

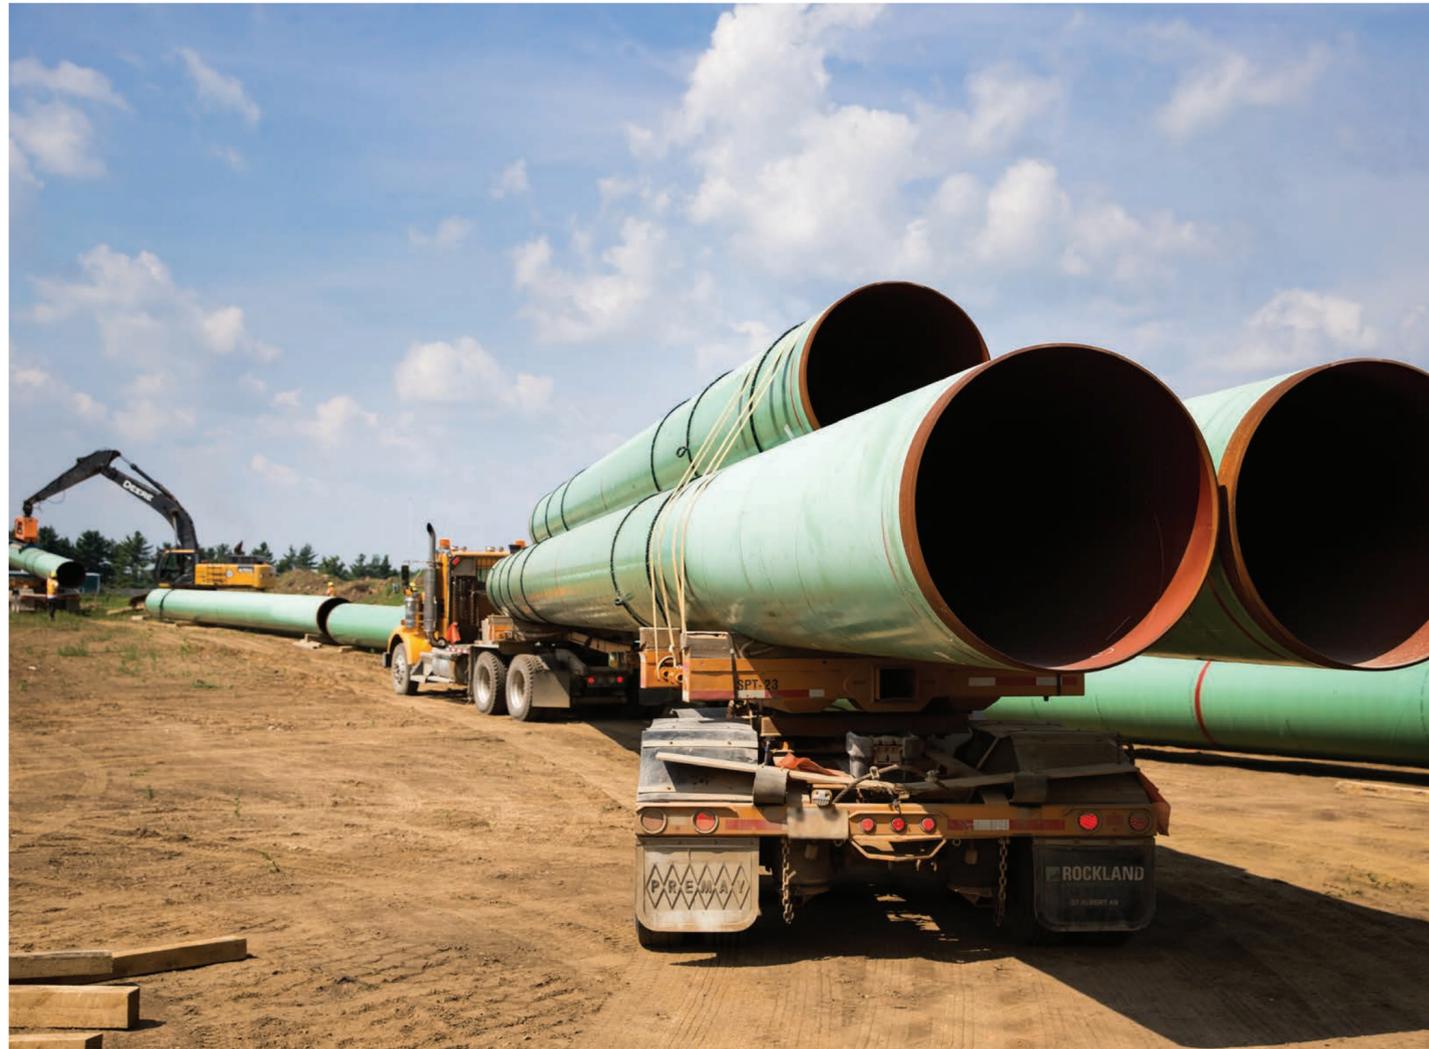
Spatial data integration is used to manage multiple generations of pipe, spanning vintage to new construction. Quality management in commissioning the pipeline database will result in an overlay of datasets that can be trusted to safely operate the pipeline over its life.
