Haldon Range Dam.

# Small dam, big task

Craig Scott from MWH gives an engineer's personal reflections on managing an emergency dam decommissioning

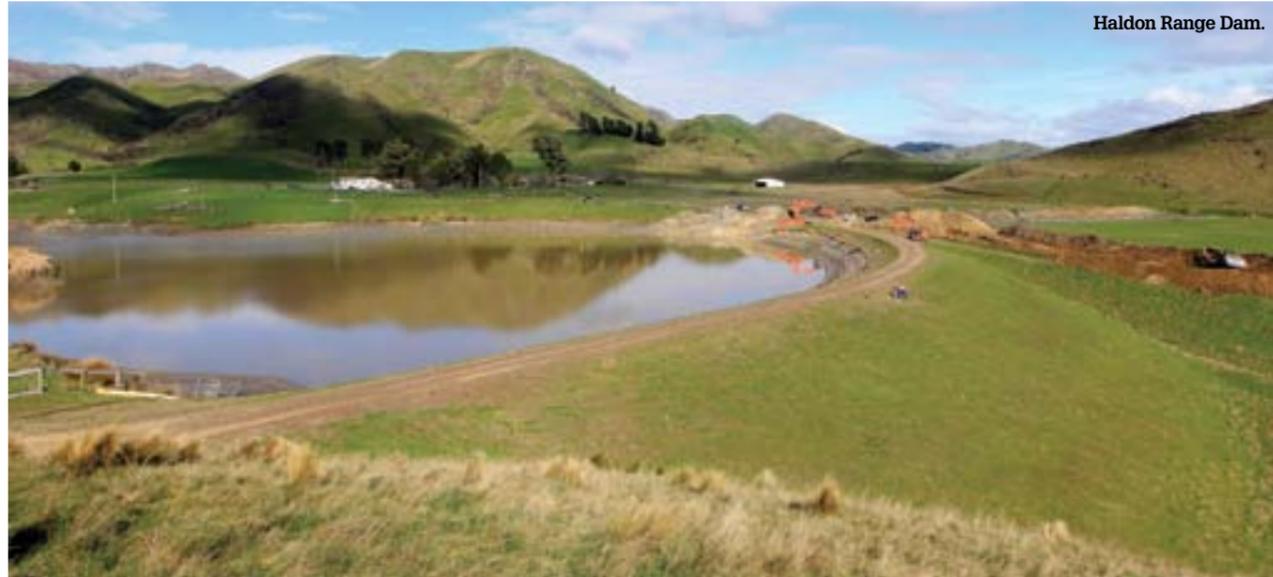
A month later, the Marlborough region and the dam was subject to a second series of earthquakes, this time much stronger with the epicentre very close to the dam location. Again I inspected the dam; noting significant crest cracking, right abutment separation, and complete slumping failure of the entire upstream face. In the region there was significant damage to regional infrastructure including homes, businesses and local infrastructure such as roads and bridges and services.

Contractors were on site two hours after my inspection and a series of four stages of excavation works were undertaken over the next seven days to lower the reservoir level 4m; a level I assessed as likely not to cause property damage in the event of a sudden release to the reservoir.
